## **ArcelorMittal Dofasco #2 Blast Furnace Stove Repairs**

### **ARCELORMITTAL DOFASCO # 2 BLAST FURNACE STOVE REFRACTORY FINDINGS AND INNOVATIVE DESIGN AND REPAIR SOLUTIONS**

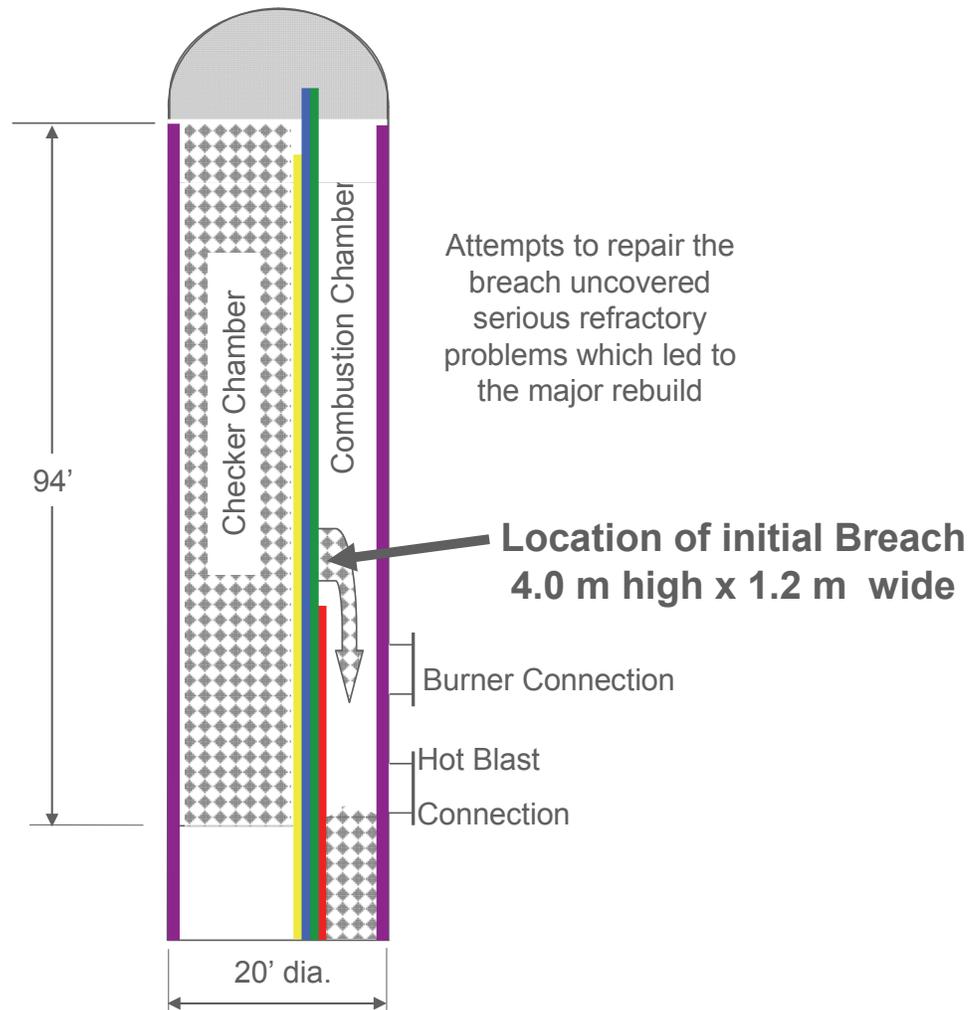
Figure 1 Stove Vertical cross-section with the damaged area

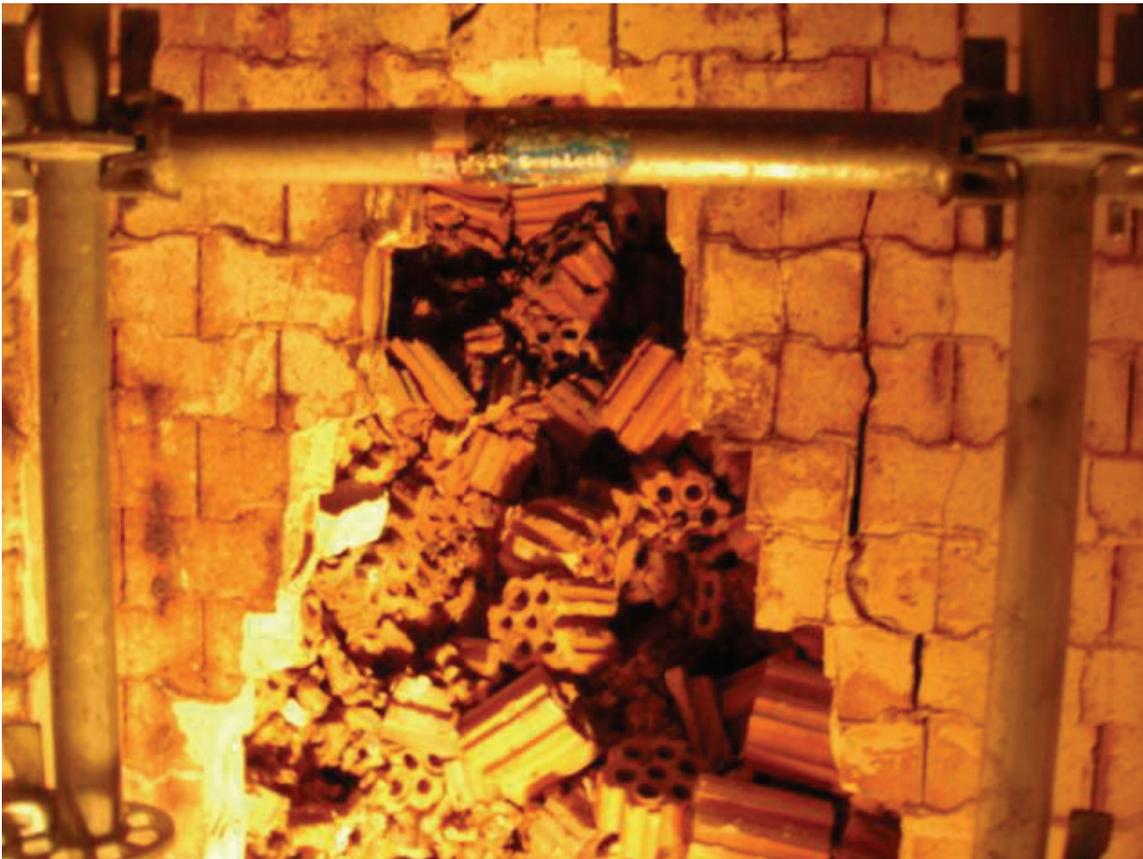
On June 15, 2008 a camera was lowered into the combustion chamber well to locate the breach. A large collapse of the skin wall was noticed, approx. 2 meters in width at a height of 5 meters. A hole in the dog bone wall 1.2 meters by approx 4 meters high permitted the displacement of a large number of checker bricks. Open joints and vertical cracks in the skin wall were evident. Attempts to repair the breach uncovered other serious refractory problems which led to the major rebuild.

Figure 2: The hole in the partition wall

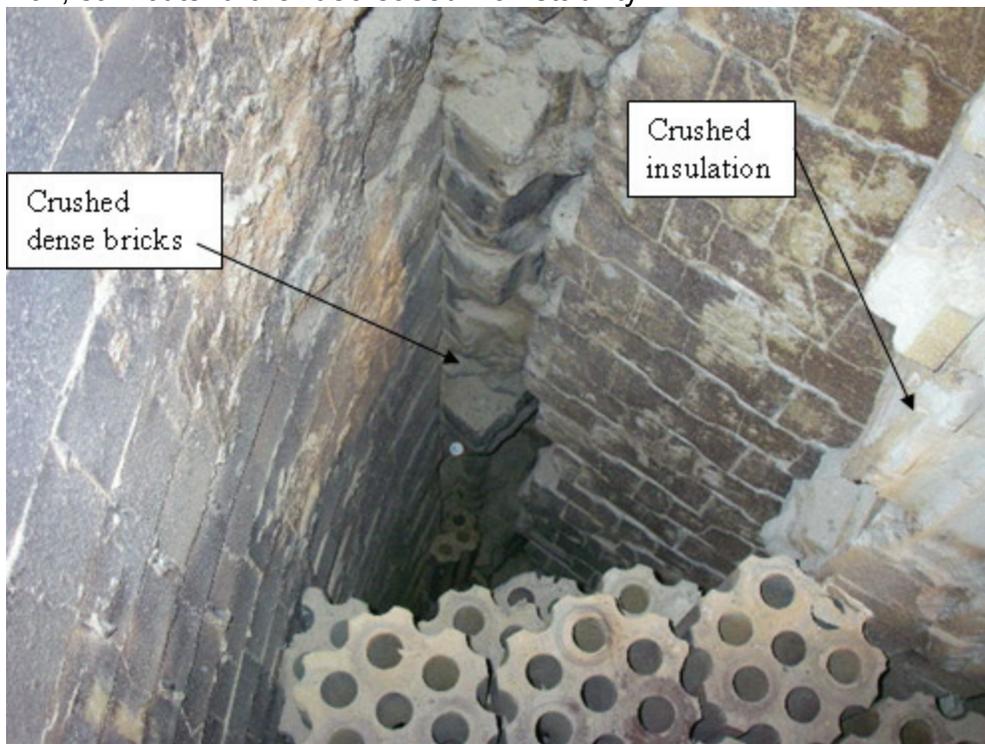
expansion/contraction temperature on cool down and then on heat up. Longitudinal cracking in the second layer, dog bone wall, provided evidence of the effects of this practice. Vertical cracking in the dog bone wall was first diagnosed as a design issue but contributing to the lack of expansion allowance is the belief that excessive vibration caused the existing expansion joints to pack with crushed brick inhibiting expansion of the brick. This lack of expansion caused severe forces to build up in the corners of the combustion chamber resulting in crushed brick.

Figure 3: The crushed corners

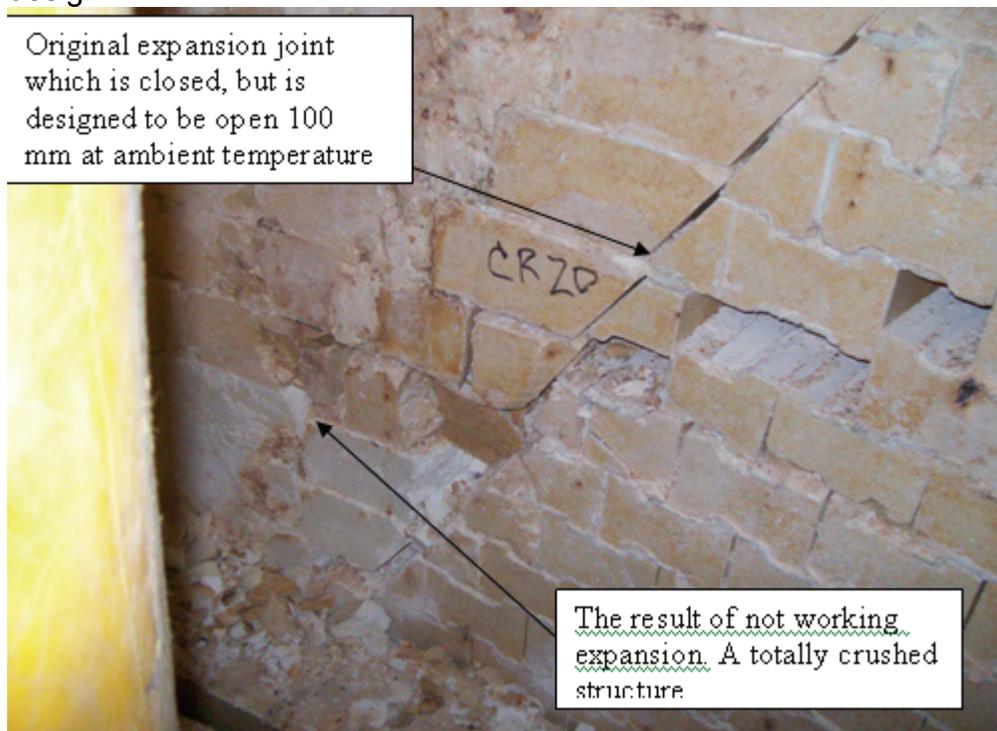
Expansion allowance was an early issue with these stoves dating back to the 1988 repair. No.4 stove required extension repairs to its skin wall which were all attributed to expansion problems. As a solution to the neighboring #5 stove a decision was made to create the necessary expansion allowance by vertical saw cuts in the combustion chamber skin wall up to a height of 5 meters. The vertical saw cuts created columns of brick, without any interlocking system in between these columns.

Figure 4: The compromised Xmas tree expansion joint design under the Dome

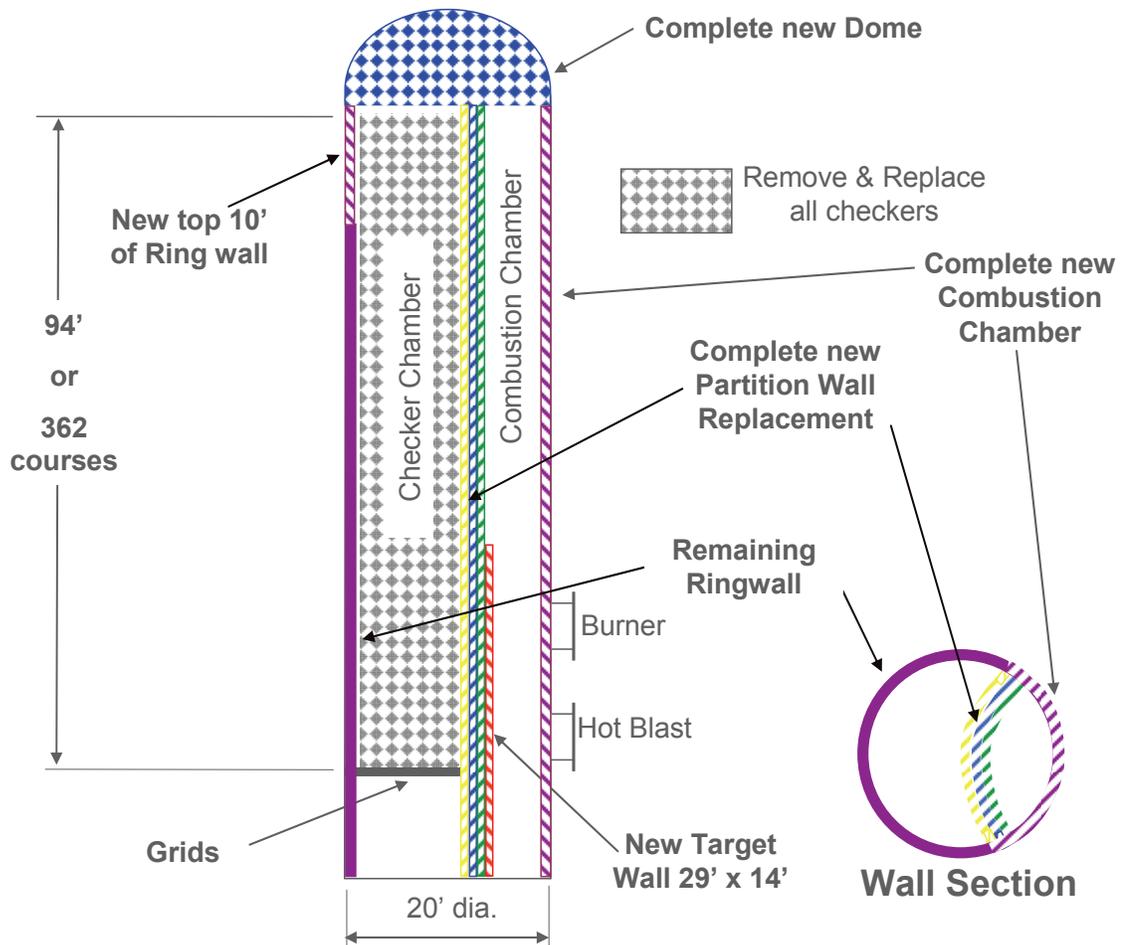
Figure 5 The repaired areas

The Stove was demolished in sections; the initial hole in the combustion chamber was thought to be locally repaired at first. Further exposure of the damaged area revealed that the damage was much more substantial than was initially visible from within combustion chamber. After the checkers had been removed up to the bottom of the visible hole in the wall it was clear that the majority of the walls were in bad shape. The expansion system for the silica walls in the combustion chamber entailed a special expansion system under the Dome by means of a so called "Xmas tree" construction. This expansion system had failed over the years and had blocked the silica wall expansion under the Dome. When the hot face wall was removed in the combustion chamber this expansion system in the Dome support wall became visible, it became clear at this point that it was impossible to support the Dome safely and it was decided to remove the Dome. The Stove was demolished with the exception of the grids and about 2/3 height of the ring wall on the checker side. The decision was also made at that time to remove all silica brick from the design.

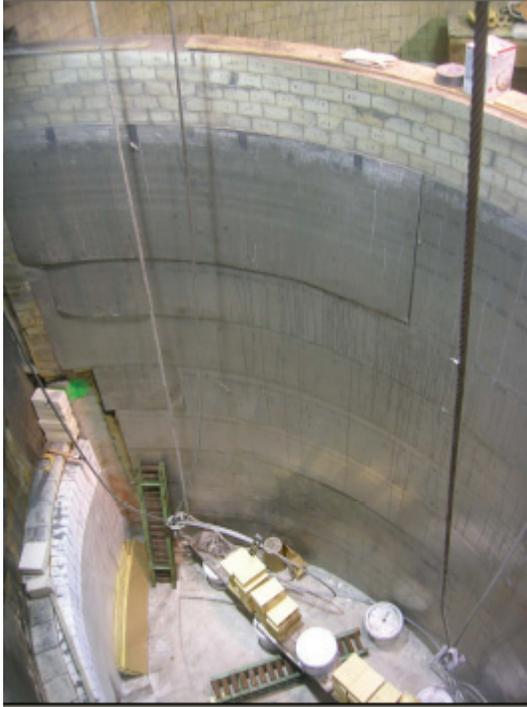
Figure 6: Gas Tight Barrier in Combustion Chamber wall.

The original design included an insulating wall on the checker side of the partition wall. Due to differential expansion and the forces of differential checker and wall movement this layer was mainly crushed and fractured. In the new design this wall was eliminated and replaced with an insulation wall in between the partition and combustion chamber wall. Incorporated in the design was the need to provide a gas tight barrier between the combustion chamber and the checker chamber. See Figure 6 showing the installation of stainless steel sheets within the wall design. The final design also included an increase in the combustion chamber cross sectional area to assist in reducing stove vibration.

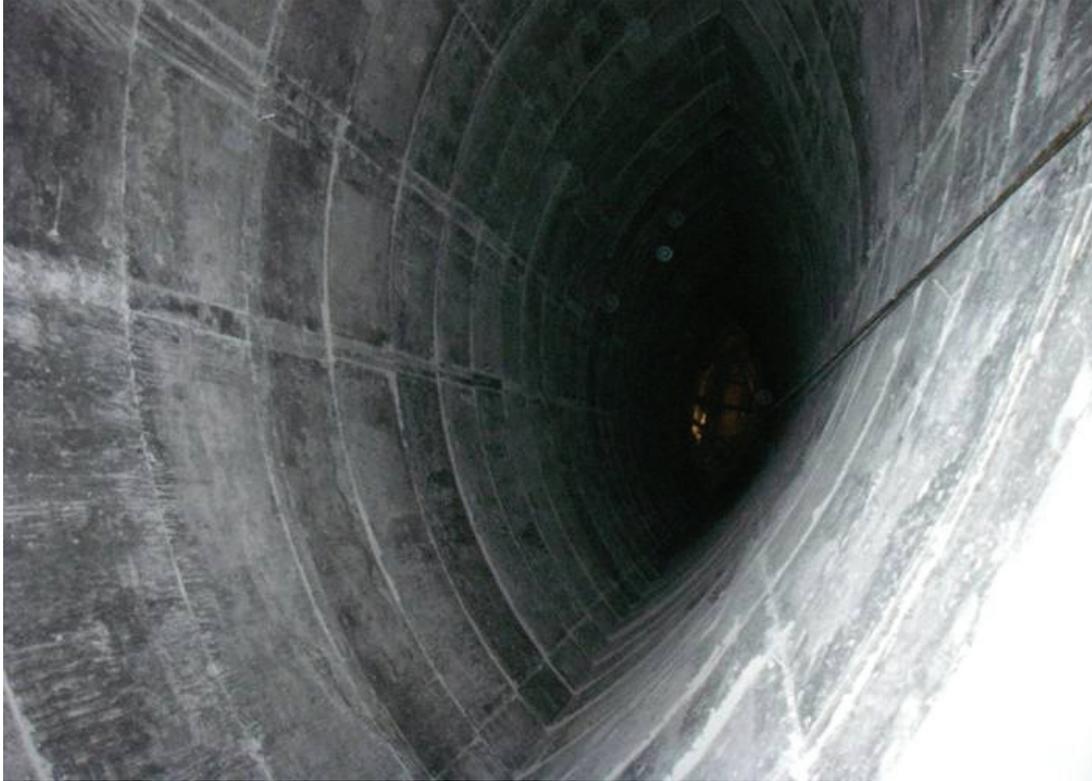
Figure 7: The Castable Combustion Chamber

The main partition wall on the checkers side was built using standard stove key bricks; the middle expansion joint was formed using pre-cast shapes. This wall was the main form used together with the checkers as the form for the castable inner combustion chamber walls. An integral part of the construct ability was the use of a preformed acrylic expansion joint.

Rigid enough to support a castable pour, this design also provided the necessary tongue and groove interlock. The material's thermal properties and ignition characteristics made it a very good expansion joint selection. An estimated 700 sq. feet of this acrylic sheet was burned out during heat up of #5 Stove with no visible emissions.

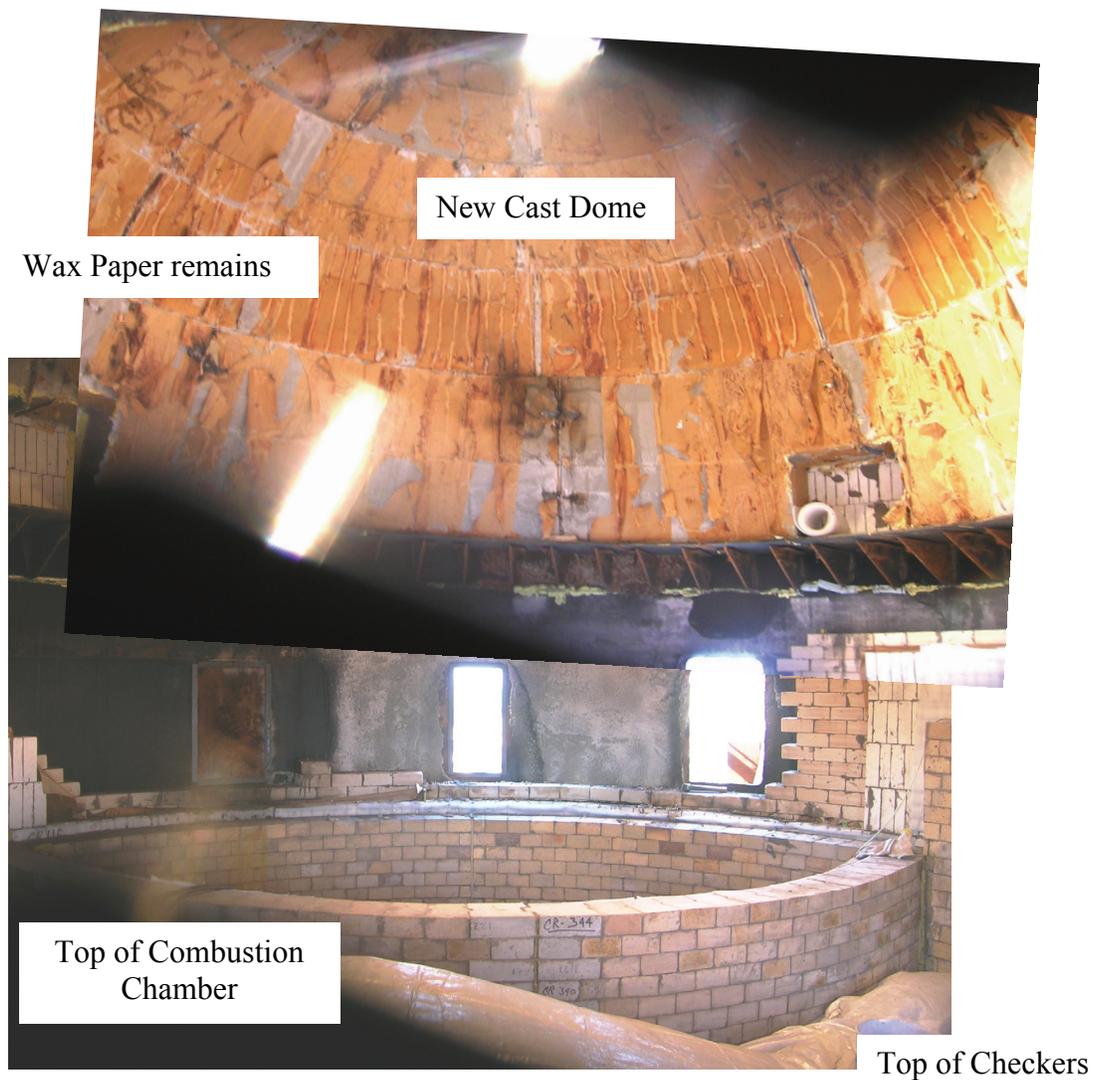
Figure 8: The cast dome supported and the Walls coming up.

To further improve on the schedule the Dome was constructed independently from the walls. The Dome Hot Face was cast in place in sections using an “igloo type” form. The Dome was designed with a large Tongue and Groove construction to lock in the different sections but the key was designing for the required independent expansion of the different sections. Extensive laboratory work to develop a suitable refractory material was required to suit this particular application and support this project.

When the walls came up to meet the Dome the underpinning construction was removed in sections and the walls were bricked up to support the Dome. This construction approach required the design and installation of a platform capable of supporting 60 tons of castable while workers below continued to lay brick and install checkers.

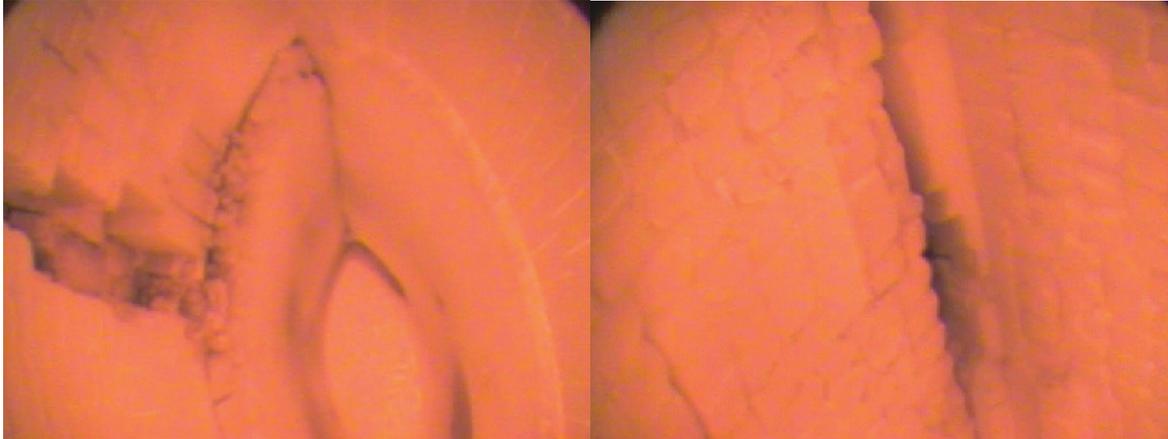
was performed externally using strategically placed engineered nozzles, core drillers and a gunnite crew who had the services of a high temperature camera to provide visual direction. Visual inspection using the high temperature camera also uncovered #6 stove in the early stages of failure. In December of 2009 similar hot repairs were performed to #6 Stove to stabilize the combustion chamber wall and maintain the availability of the stoves until such time as it makes economic sense to reline.

Figure 9: #6 Stove Combustion Chamber wall and corner failures
