SEVERSTAL L-BLAST FURNACE HEARTH REFRACTORIES FINDINGS AND REPAIR AT SPARROWS POINT

This paper will discuss the findings and repair of Severstal NA Sparrows Point “L” Furnace hearth refractories during the late 2008 to early 2009 planned outage. The significance of improving the refractory configuration, upgrading of the hearth monitoring systems & practices to match the campaign strategy goals will be discussed.

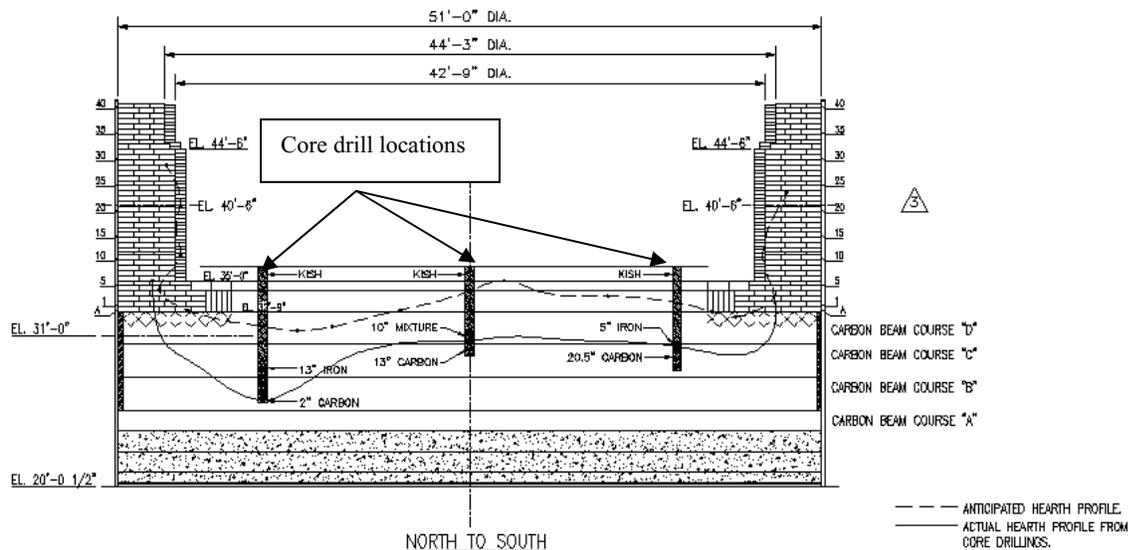
Figure 6 Profile of the Remaining Bottom

As the remaining burden was removed from the hearth, test cores were taken to validate condition of the remaining bottom refractory and compare with those test cores taken in 1992. These cores were also taken to further validate the bottom to determine if the refractories left in the bottom would be compatible with the expected campaign life. At this time, it was discovered that the bottom had worn (the test core results shown, see figure 6). The location of the deepest core also correlated with the earlier bottom thermal data.

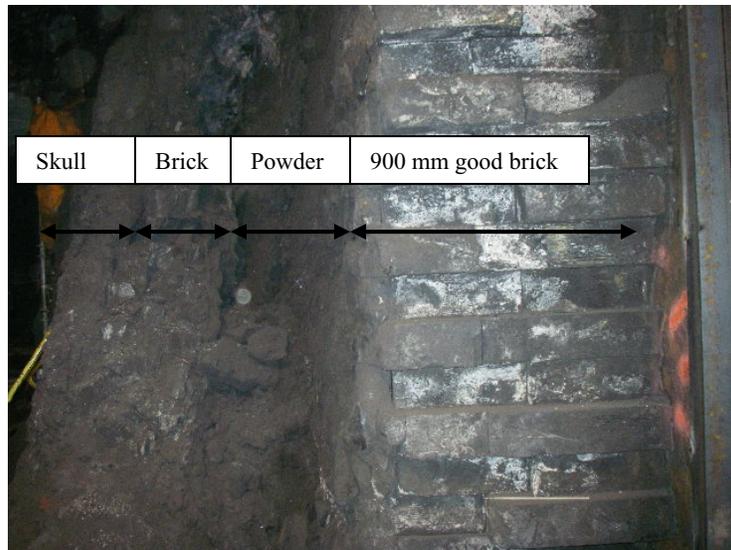
Figure 7 Hearth Sidewall Brittle Zone and Skull

The remaining exposed hearth wall in general had a very thick skull. Lower in the furnace there was about 900 mm of wall away from the tapholes. It was remarkable to see the well-known “brittle layer” phenomenon in the sidewall. In front of the wall there was a powdery skull type zone followed by a zone which contained good bricks (see figure 7 @ Tuyere #21 and figure 8 @ Tuyere #22)

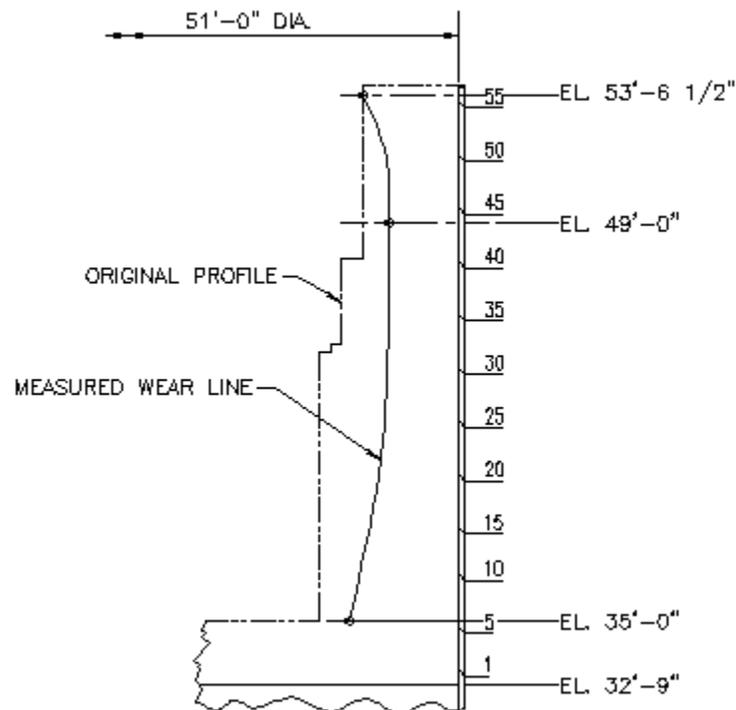
Figure 9 Typical Section through the Hearth Wall outside the Taphole Area

To be able to repair the bottom, the hearth skull had to be removed from around the furnace. The remaining hearth wall was checked and measured (i.e. outside the taphole areas) as shown in the figure 9.

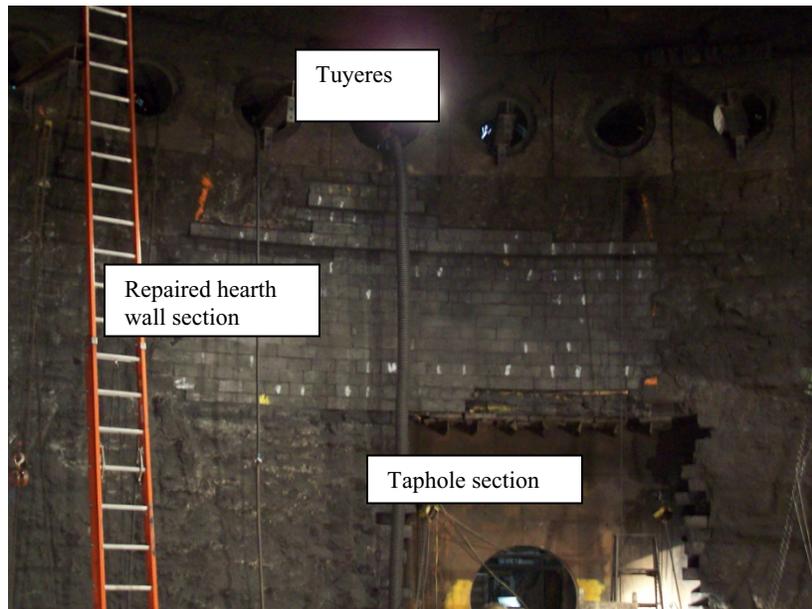
Figure 11 The Taphole Section Removed and the Repaired Zone above the Taphole.

In addition to the Taphole areas, several sections above the Taphole were also deteriorated and needed repair (see Figure 11).
