## **ArcelorMittal Dofasco #2 Blast Furnace Stove Repairs**

### **ARCELORMITTAL DOFASCO # 2 BLAST FURNACE STOVE REFRACTORY FINDINGS AND INNOVATIVE DESIGN AND REPAIR SOLUTIONS**

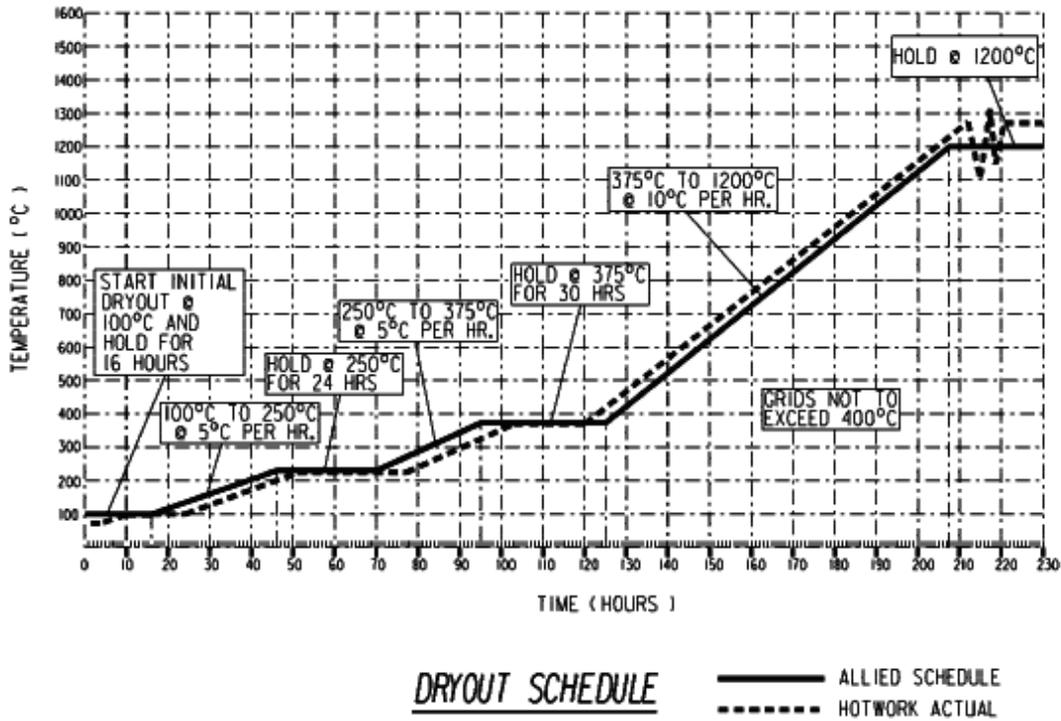
The monolithic combustion chamber walls, target walls and dome required a specific heat up schedule. Hot face and cold face thermocouples were embedded in the castable in key locations during construction to ensure a controlled and thorough dry-out. Dome thermocouples are typically used to control the heat up rate and schedule. The high readings in thermocouples located in the lower combustion chamber required that they become the control thermocouple for heat. After temperatures reached 375°C in the schedule and based on other thermocouple readings, the control thermocouple was moved back to the dome for the remainder of the heat up. The significance of this is that the previous heat ups of #5 stove, #4 & #6 as well, likely experienced the same

temperature issues during heat up in this area of the stove where the silica brick begins. This is further evidence that silica brick was used too low in the combustion chamber given the use of the stove.
