SEVERSTAL L-BLAST FURNACE HEARTH REFRACTORIES FINDINGS AND REPAIR AT SPARROWS POINT

This paper will discuss the findings and repair of Severstal NA Sparrows Point “L” Furnace hearth refractories during the late 2008 to early 2009 planned outage. The significance of improving the refractory configuration, upgrading of the hearth monitoring systems & practices to match the campaign strategy goals will be discussed.

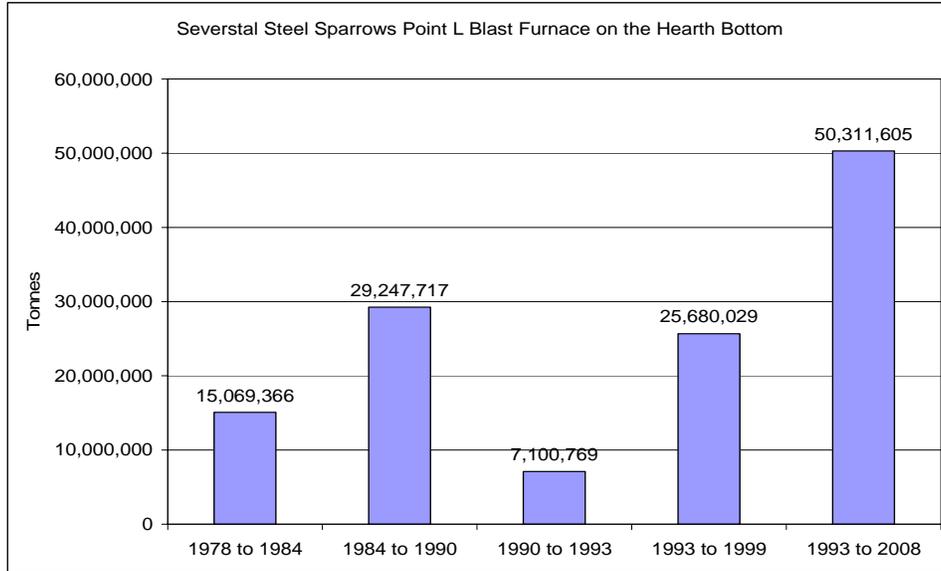
Figure 1 Severstal Steel Sparrows Point Tonnes on Hearth Bottom

Sparrows Point “L” Furnace was commissioned in 1978 and a complete reline was completed in 1990. In 1999, new hearth walls and bosh were installed. The furnace was blown down in the fall of 2008 for a 30 day scheduled internal taphole repair. The hearth wall and bottom had 24.6 and 50.3 million tons of hot metal production, respectively, before this outage (see figures 1 and 2). External taphole repairs were made from 2003 to 2005.

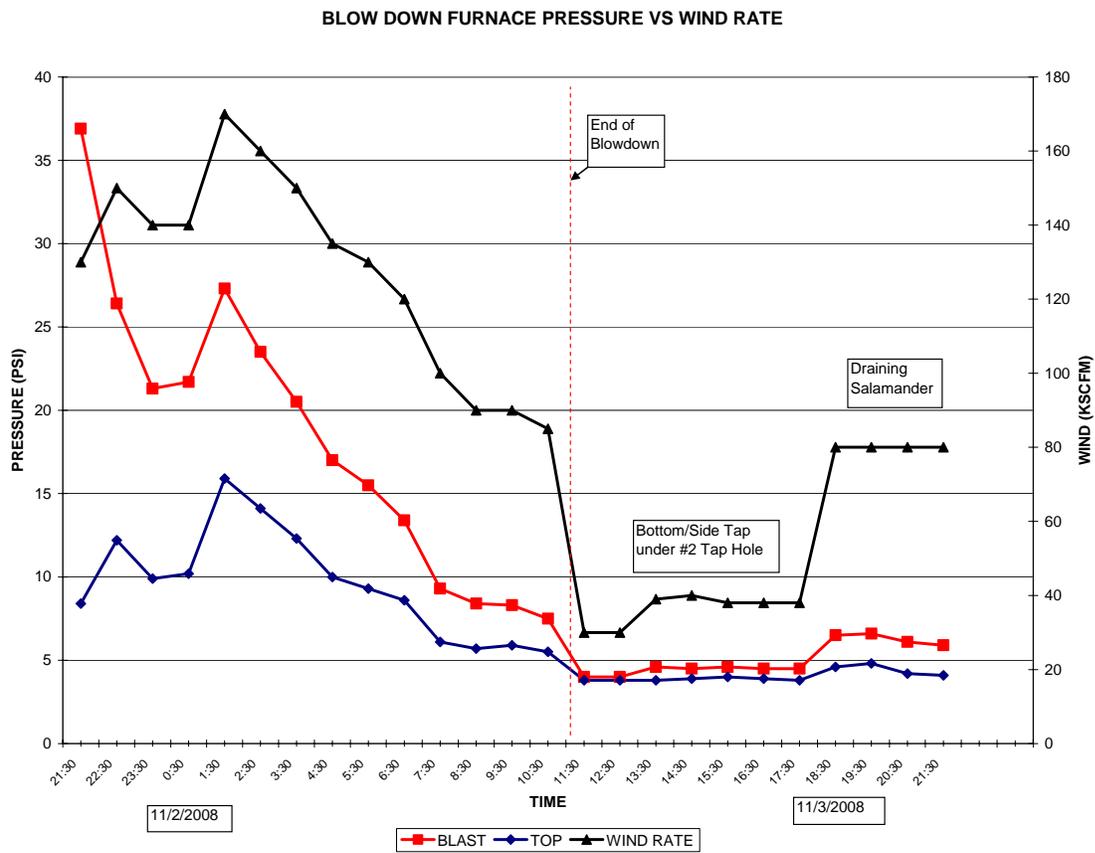
Figure 3 Blow down Pressure vs. Wind rate

“L” Blast Furnace was successfully blown down and quenched between November 2nd the 6th to prepare the furnace for taphole repairs and shotcreting of the furnace stack and belly (see figures 3 and 4). Prior to these events the salamander was tapped and ~ 438 tonnes of hot metal and slag were removed from the furnace. The last time this was accomplished was in 1999. For the new team, this was the first time they executed the task. Unfortunately business conditions extended the scheduled duration of the outage longer than required for the original scope of work. This allowed additional time to address critical repairs and concentrate on the quality of the repair.

Normally after blow down with the practice of this plant, the wind would be taken off and the furnace prepared for the quench. Instead, the pressure was maintained on the furnace to help cast the salamander (see figure 3). The wind was reduced to 64000 Nm³/hr due to the noise at the bleeders until iron was tapped at 18:00 hours. Then the wind was raised to 128000 Nm³/hr. About 398 tonnes of iron and slag were cast into the pig bed (see figure 5). The tap was deemed a success since enough liquid slag and iron were removed to insure a safe taphole repair. The tap was declared over at 21:47 hours on November 2 and the wind was taken off.

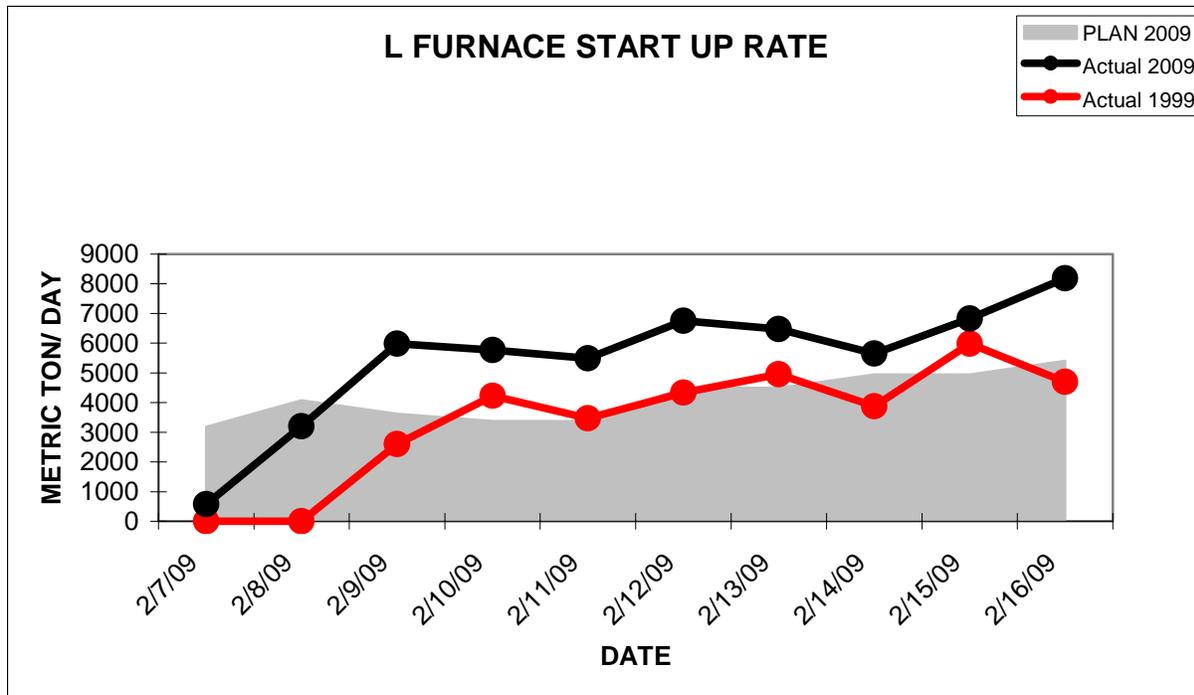
Figure 13 L Furnace Start Up February 2009

The Severstal Steel Sparrows Point “L” Blast Furnace blow-in took place in February, 2009 and hot metal was successful cast from the furnace to ladles in 36 hours (see figure 13).

The initial taphole temperatures in the graphite are below 300°C, thus the lining is fully intact. Both the repaired and unrepaired areas of the hearth sidewall and bottom have temperatures that are within safe operating limits. Although this is expected with lower throughput, the initial temperature distribution in the hearth has improved from the previous designs.

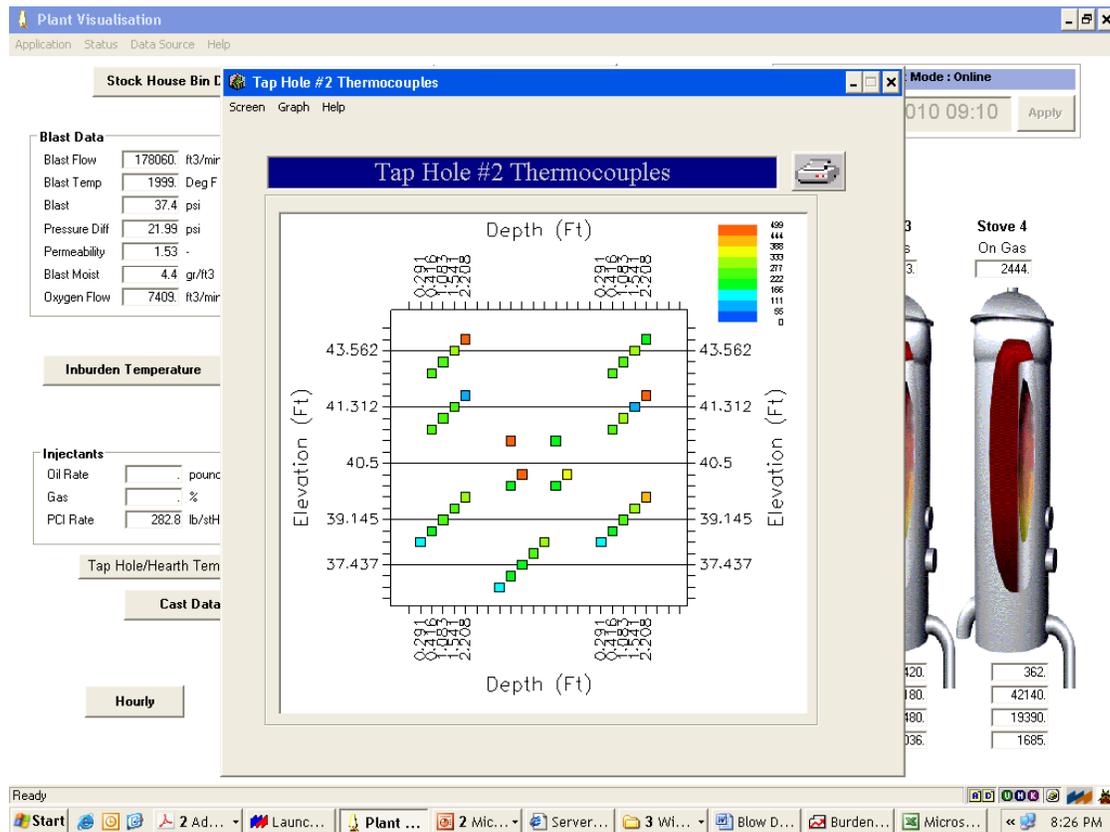
Business conditions remained unfavorable the remainder of 2009 and prevented the purchase of the desired Hearth Management computer model. Instead all the data was input to the existing Level 2 system. Alarms points were set for all thermocouples and in-house personnel developed graphic displays to aid in the monitoring of critical data. (see figures 14 and 15)

Figure 14 Seven thermocouple arrays in the #2 tap hole panel and six thermocouples embedded in the core of the taphole can easily be viewed from the Level 2 Plant Visualization screen.

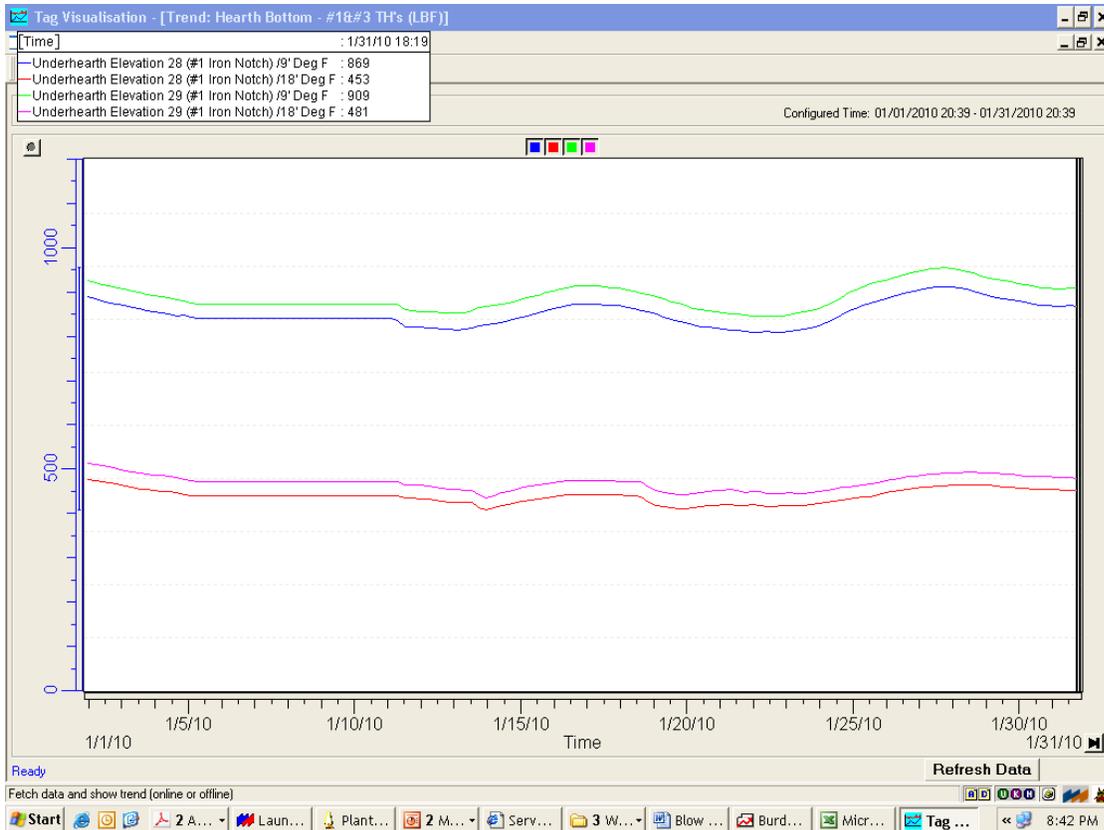
Figure 15 The under hearth thermocouples in-line with #1 tap hole are trended in the Level 2 system.
